## ***BRAKE SHUDDER – HUB FACE CLEANING***

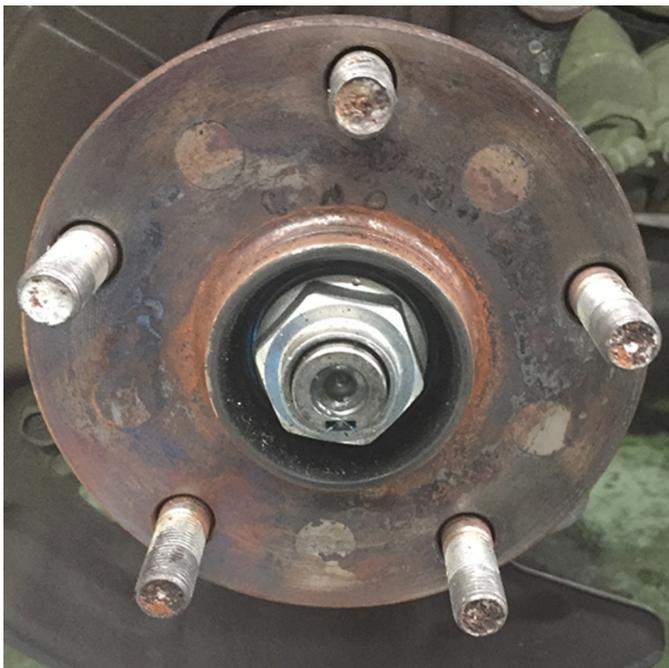
**Figure 1**  
Hub showing built up rust and scale.

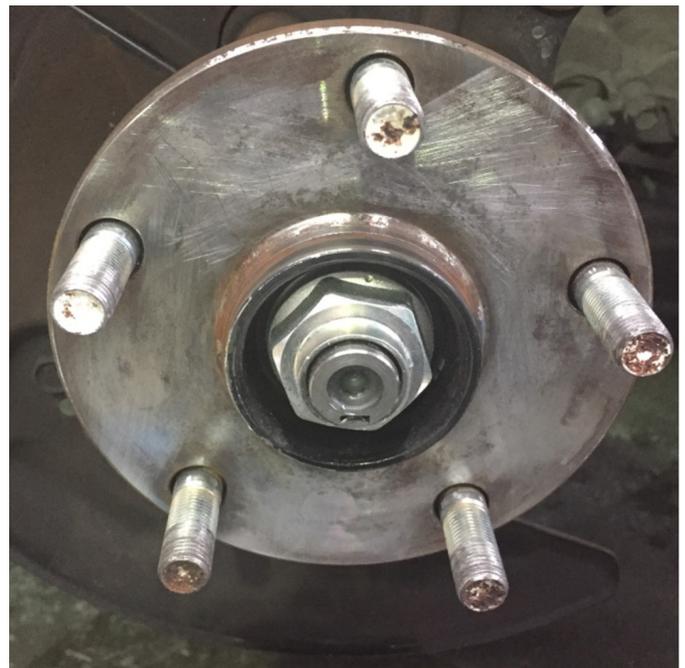
**Figure 2**  
A cleaned hub face ready for fitting.

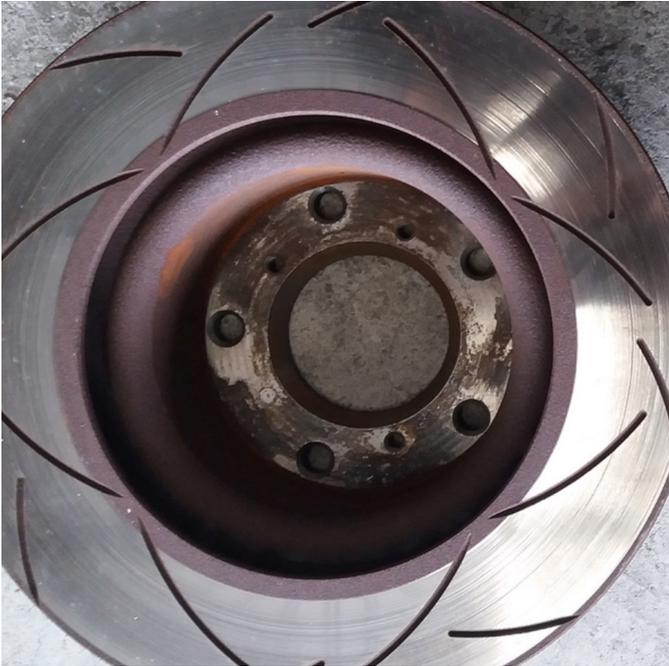
Figure 3a

**Figure 3** and **Figure 4** show examples of disc rotors that have been improperly fitted to hubs that have not been cleaned. Both show compression marks where the rust and debris had been captured between the faces.

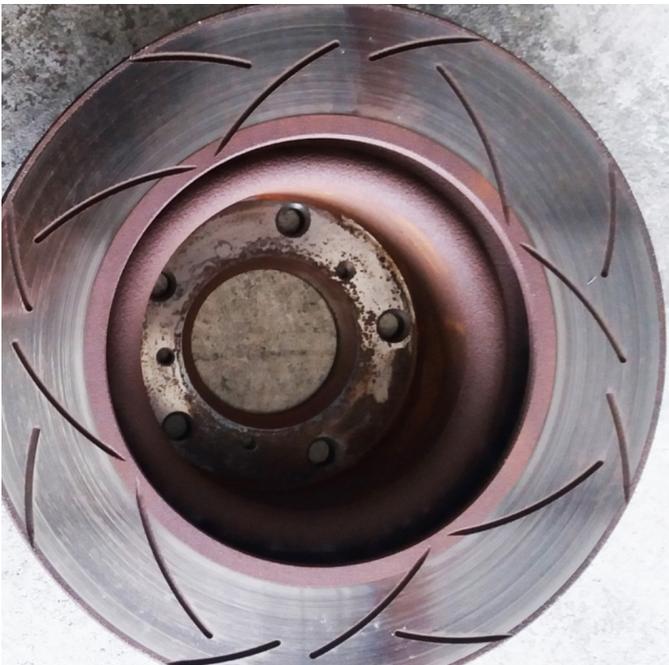
Figure 4a

**Figure 4a** clearly shows a large amount of contamination on one side which produced a greater degree of run out in the rotor assembly. The circle impressions are burrs from the jacking screws used to remove the old rotors.

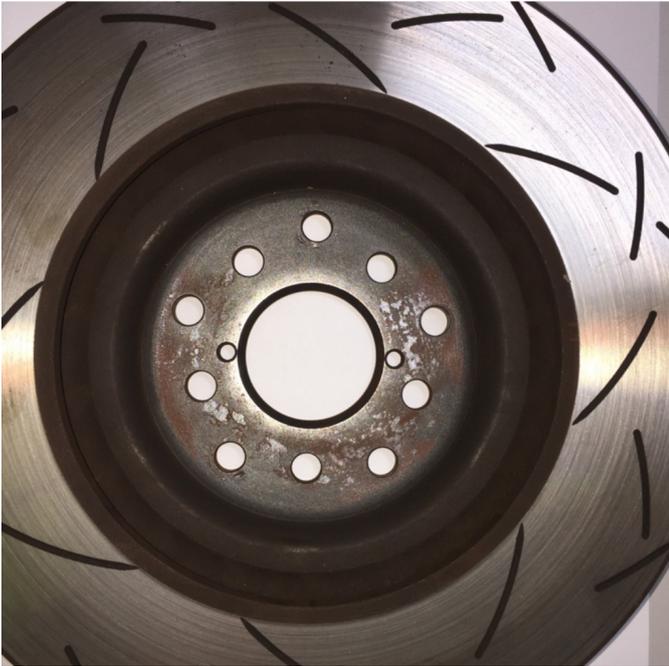
Figure 5a

**Figure 5** is a 4000 series rotor with similar compression marks from improper fitting. As the 4000 series rotors are heat treated the material is darker in colour.

In this case the rust and debris captured between the faces is very clear and concentrated to one side of the mount face. This rotor was found to have severe brake shudder.

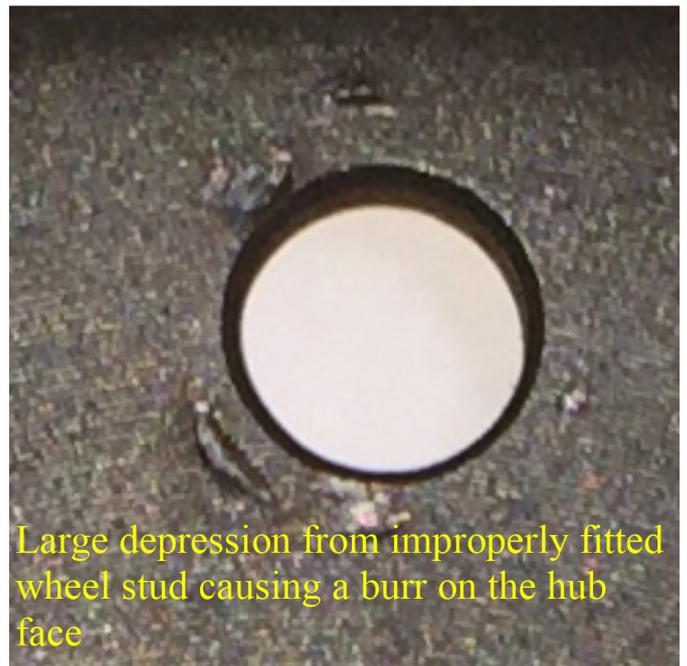
Large depression from improperly fitted wheel stud causing a burr on the hub face
