FRICTION MATERIAL DEPOSITS

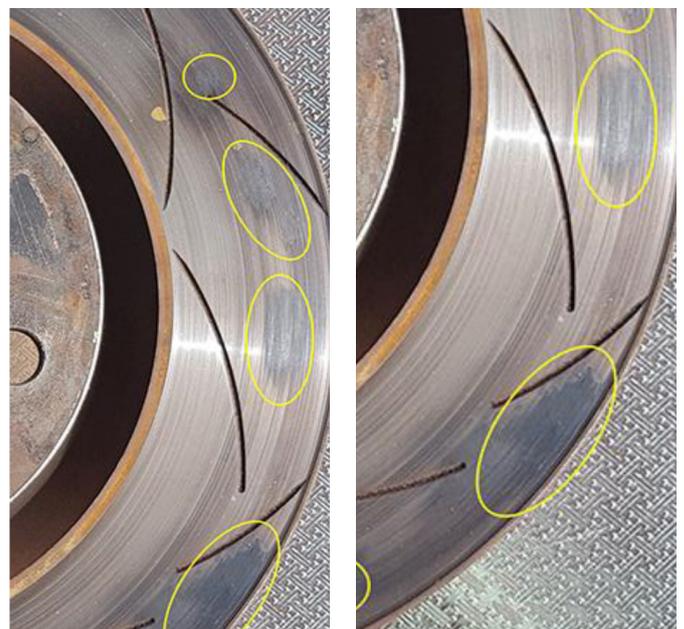
In most examples, you will see friction material deposits directly after a slot or hole.

If a problem occurs and friction material deposits are present on your disc rotors this can be rectified if addressed early. For very light deposits, an upgraded brake pad material fitted often removes the deposits within a few days of normal driving. With more heavier deposits the friction material deposits can be removed by light sanding with emery paper or a very light skim on a brake resurfacing machine. The extreme worst-case scenario is when the material deposits generate heat spots in the disc rotor material which can happen if the issue is not address. These disc rotors must be discarded
